**TEST REPORT**

**Number:** SAC/0595/21      **date:** 11/10/2021  
**OMECO Ref.:** 2484/21      **Page** 1 of 5  
**CUSTOMER Ref.:** ord.1837/00 15/9/21

**Sample:** No. 2 SHAPED GALVANIZED MESHES ~ 450x450mm and No. 1 REFERENCE PLAIN GALFAN COATED MESH

**NEUTRAL SALT SPRAY CORROSION TEST  
EN ISO 9227:2017**

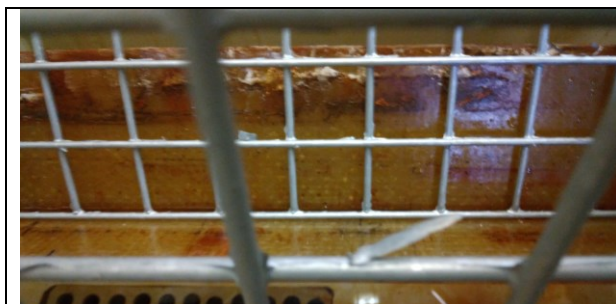
Fig. 1 : Shaped galvanized meshes showing some zinc coating burrs (before test start)

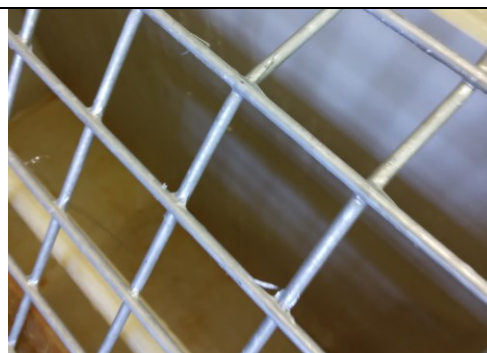
Fig. 2 : Detail of one of the galvanized meshes before test beginning.

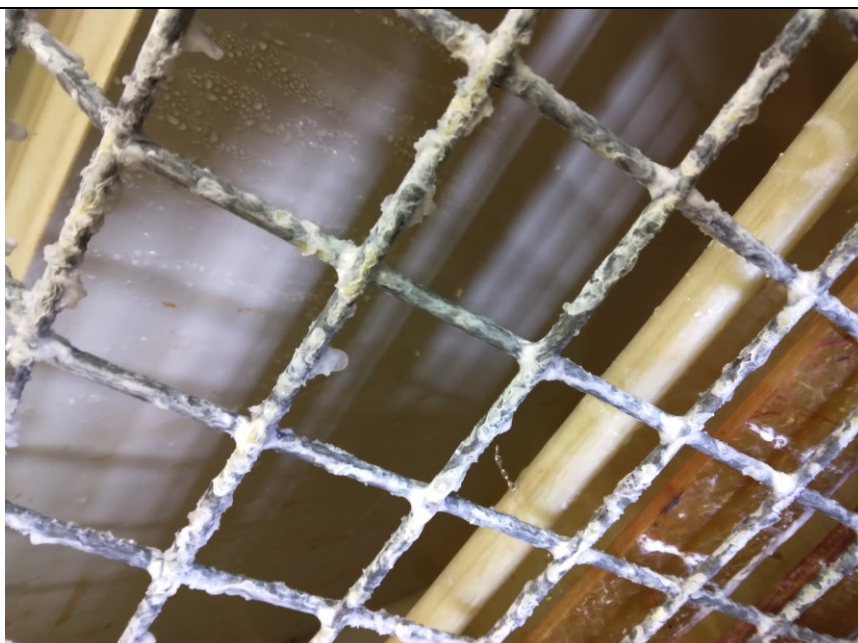
Fig. 3 : first appearance of reddish products below the white oxidation layer after 96 hours of NSS exposure

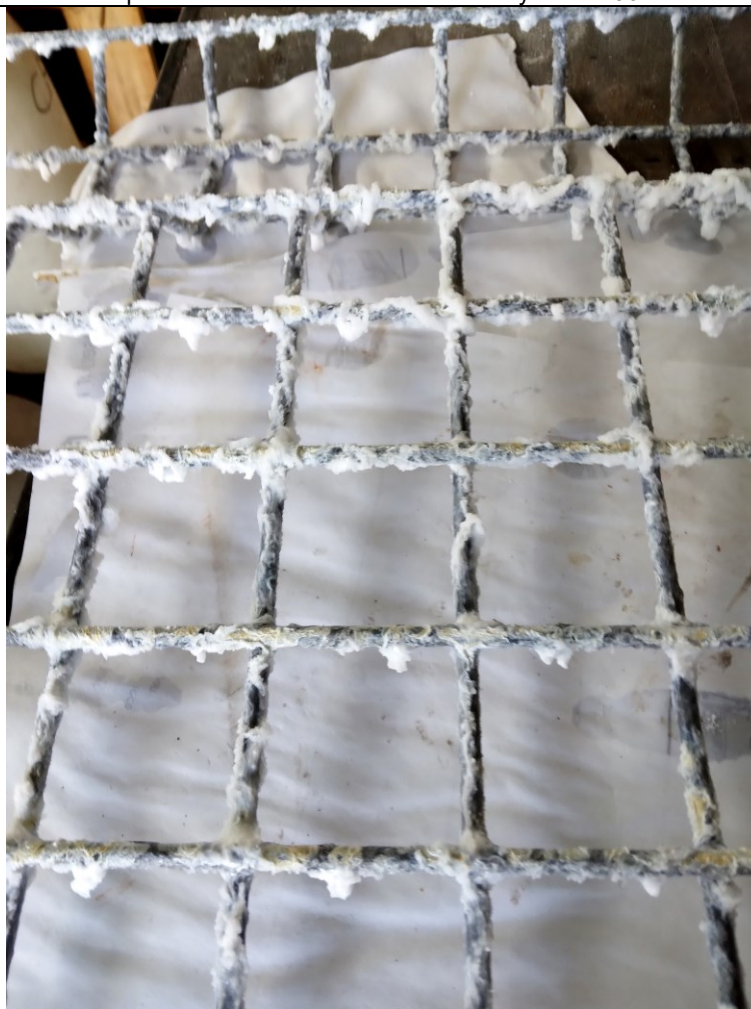
Fig. 4 : red rust, below the white oxidation layer, after 168 hours of NSS exposure (both mesh rod and mesh rods intersections)

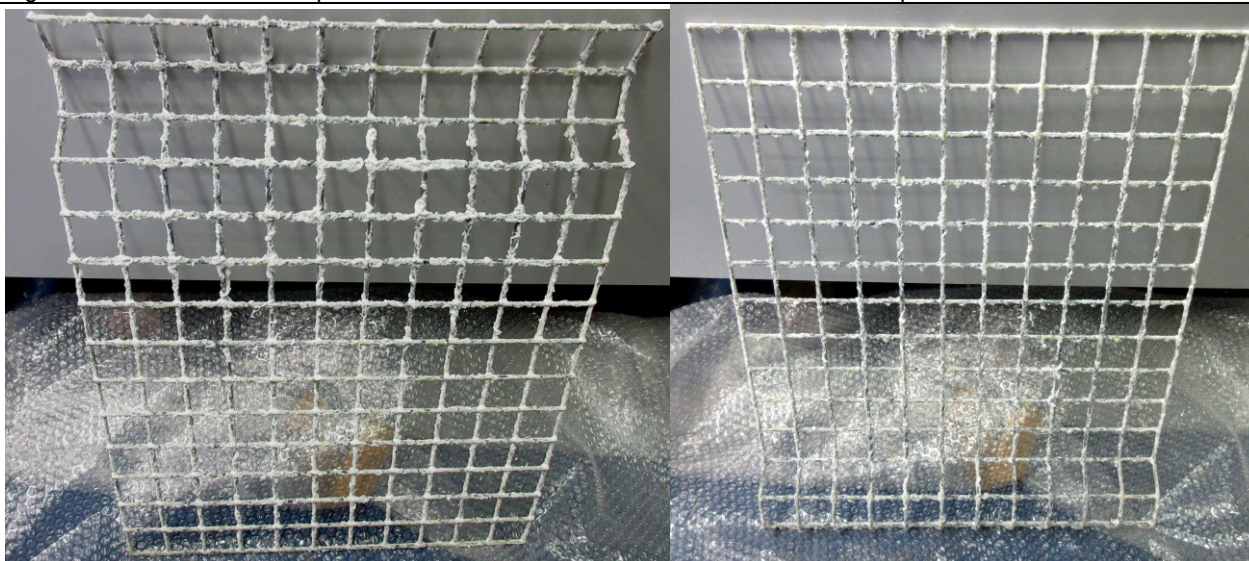
240	b. about the whole of the exposed surface c. spots at the mesh rods intersection points and on the mesh road (about 10% of the exposed surfaces) – figg. 6-7-8	b. on about the whole of the exposed surface. Figg. 9-10)

Fig. 6 : Shaped Galvanized Meshes after 240 hours exposure, final rinsing and drying (test end)

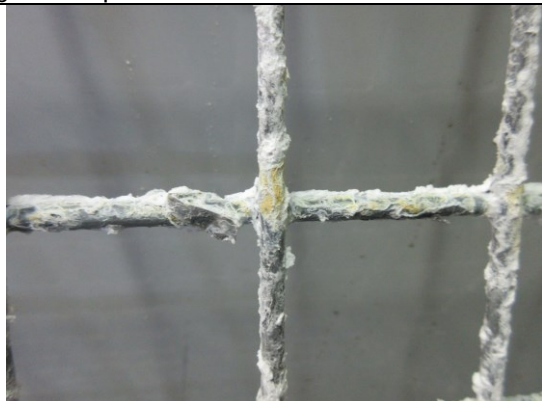
Fig. 7 : Shaped Galvanized Meshes after 240 hours exposure, final rinsing and drying (test end)

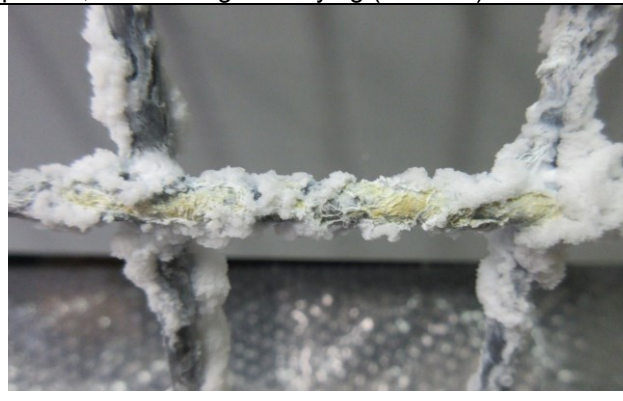
Fig. 8 : Shaped Galvanized Meshes after 240 hours exposure, final rinsing and drying (test end)

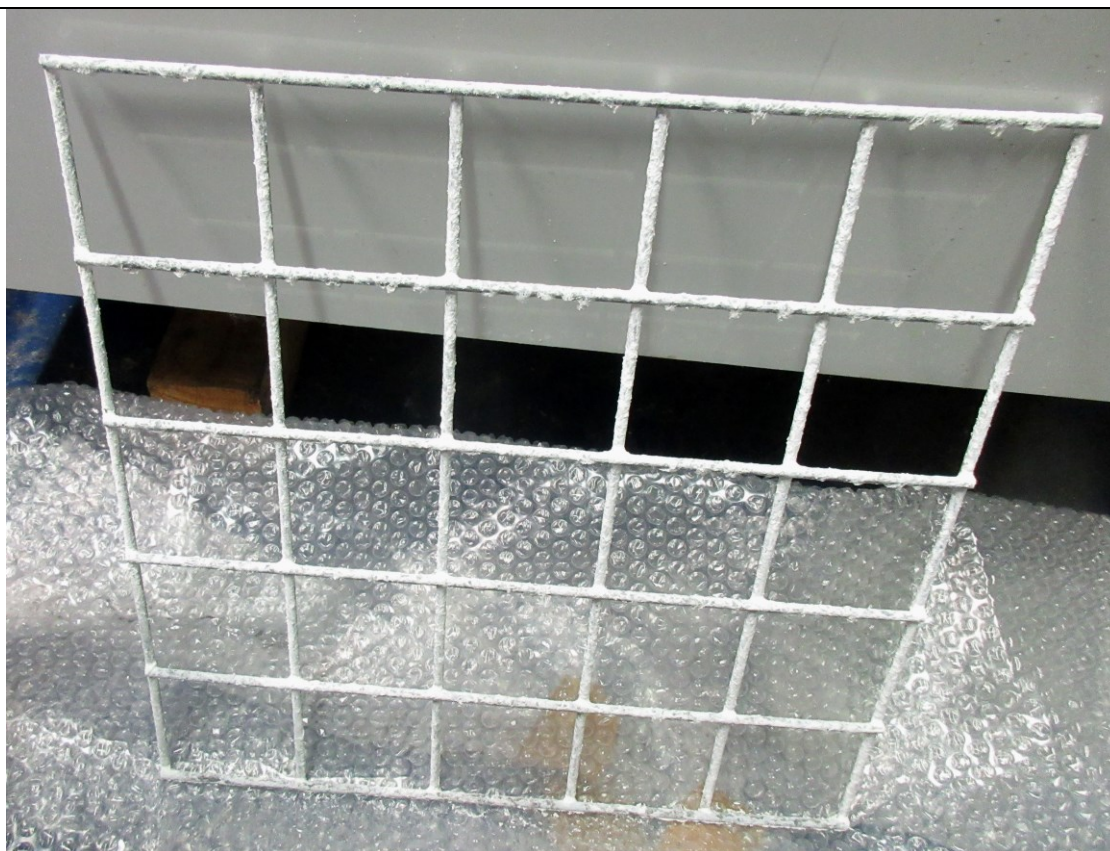
Fig. 9 : plain Galfan reference mesh after 240 hours exposure, final rinsing and drying (test end)

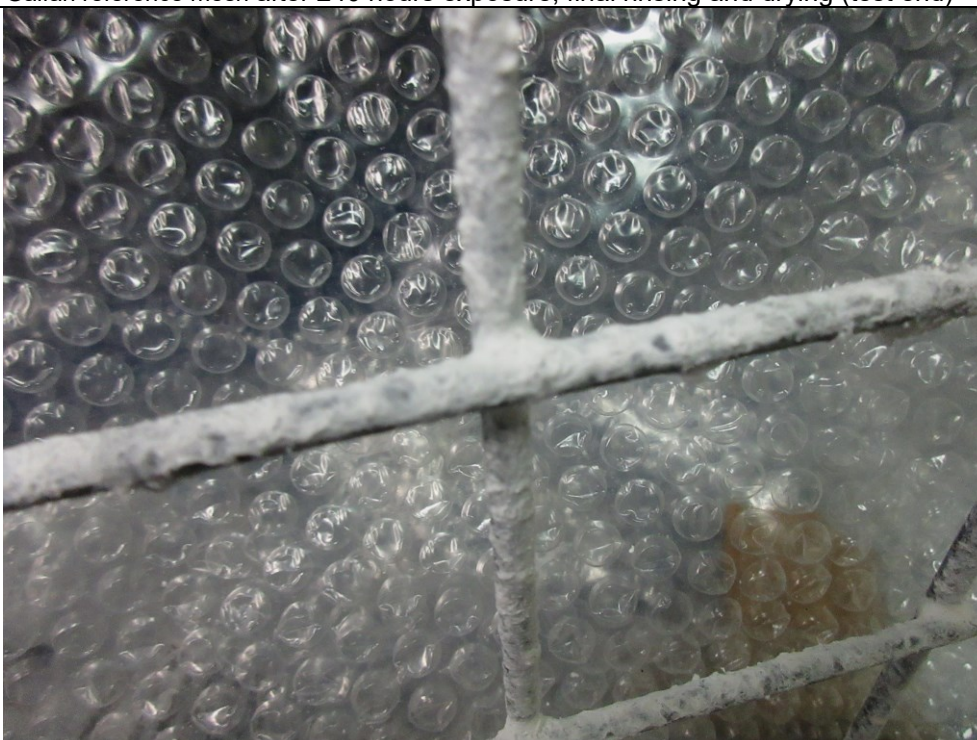
Fig. 10 : plain Galfan reference mesh – detail after 240 hours exposure, final rinsing and drying (test end)
